HiPAP® Transceiver x81

Information letter

HiPAP® Transceiver x81 backplane improvements

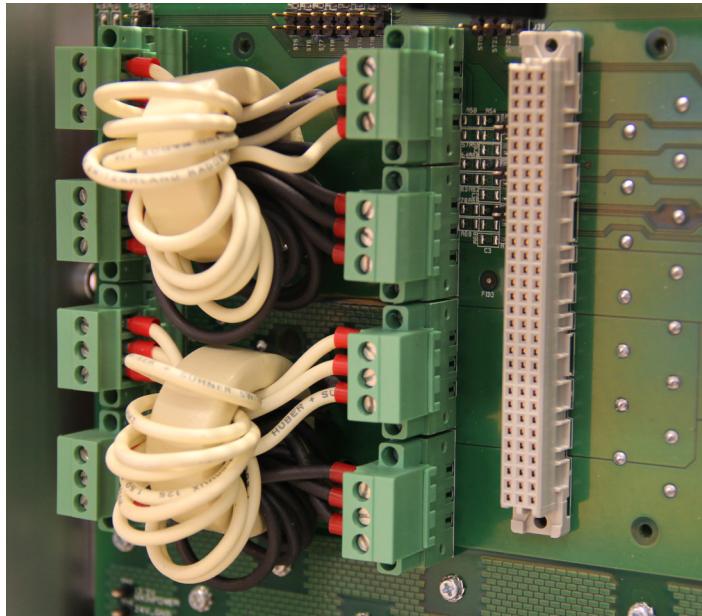
It has been reported that connectors connecting the solenoids L1 and L2 to the HiPAP Transceiver backplane are burnt on some installations. P3, P4, P5 and P6 for L1 and P7, P8, P9 and P18 for L2.

Picture 1 shows the old connectors reported with problems.

A short term fix in case the connectors are burnt is to:

1. Remove the plug.
2. Solder the wires directly to the backplane in the same order as they are connected to the plug, to get the HiPAP system back in operation.
 - Our advise is to order a new rack (without the TRX boards) and replace it with a new one, along with new power supplies.

If the connectors are still intact, then it is recommended to tighten all the screws connecting the plugs to the backplane.

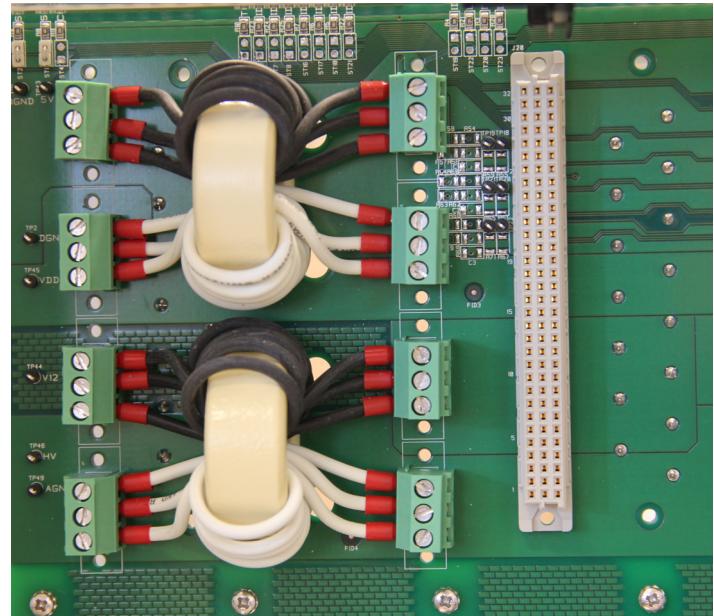
Picture 2 shows the corrections made to terminal blocks.

The connectors are replaced with terminal blocks on the new backplanes to avoid this problem.
