KONGSBERG

RPT transponder pressure relief valve verification and repair	
<i>Product:</i>	Kongsberg Maritime RPT transponder
<i>Contents:</i>	RPT dismantling procedure RPT pressure relief valve verification and repair procedure

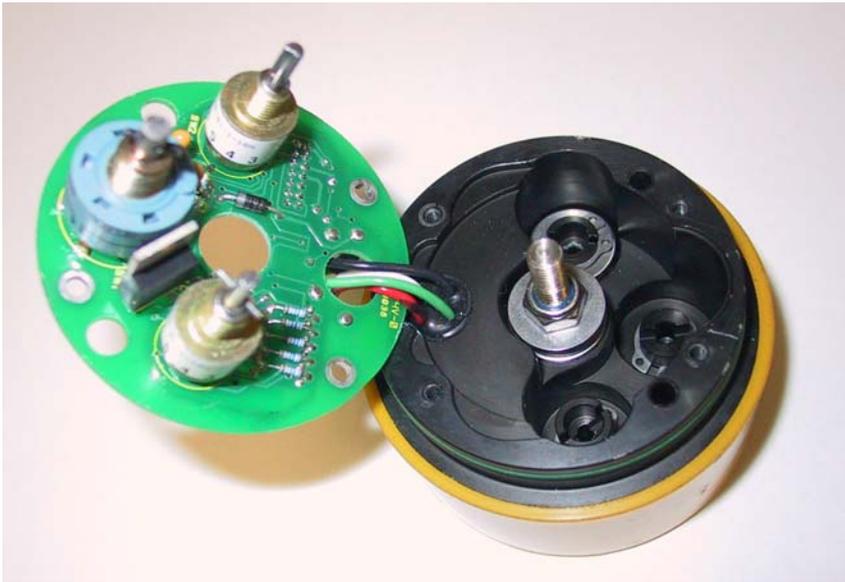
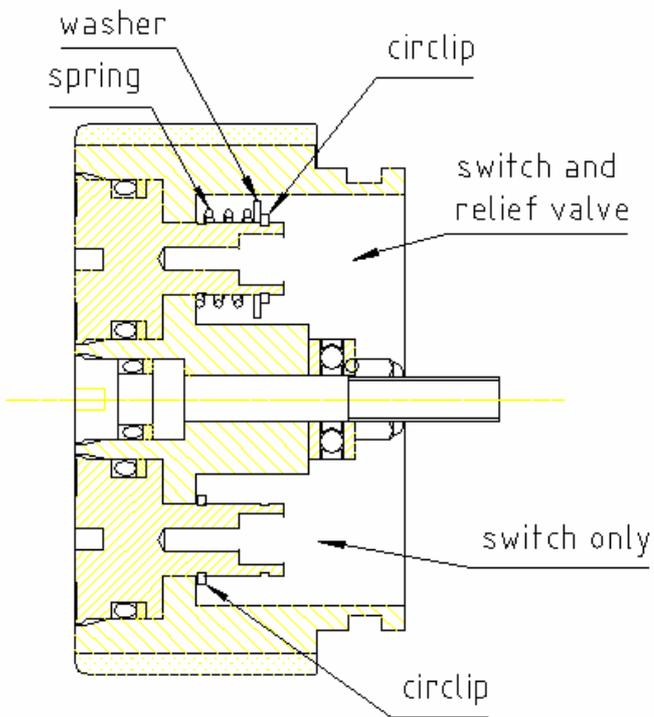
The two channel selector switches are identical, but should be installed differently. One acts as rotary switch only, the other one acts both as switch and pressure relief valve.

The one acting as rotary switch only should have one circlip installed right next to the surface of the endcap, and nothing else. The circlip is visible at the bottom of the recess.

The other switch acting both as switch and pressure relief valve should have:
a spring,
a washer, and finally
a circlip at the very end.
Because this is recessed, only the washer and circlip are visible.

If the valve has been incorrectly fitted with a second (problem causing) circlip this will now be visible at the bottom of the recess (looking exactly like the other "switch only" switch). See attached drawing.
Remove and discard this second circlip.

5. To verify correct installation of the relief valve, remove the visible circlip, then the washer and the spring.

Replace the spring, washer and top circlip, in this order.
